# N.S.W. MASTER BUILDING INSPECTORS

## STANDARD BUILDING INSPECTION REPORT

<b>ADDRESS OF PROPERTY:</b>	<i>Address deleted</i>
<b>OWNER'S NAME:</b>	<i>Name deleted</i>
<b>AGENT:</b>	<i>Name deleted</i>
<b>GENERAL DESCRIPTION OF PROPERTY:</b>	Double brick house constructed on timber beam and pier flooring with a timber framed fibro section at the rear exhibiting sagging of the roof, deterioration of the roof tiles and requiring a number of other repairs as detailed
<b>ACCOMMODATION:</b>	Three to four bedrooms depending on the configuration of rooms
<b>AGE OF PROPERTY:</b>	Appears to be approximately 85 years old
<b>NEIGHBOURING PROPERTIES:</b>	Houses of varying styles and ages
<b>WEATHER CONDITIONS ON DAY OF INSPECTION:</b>	Rain

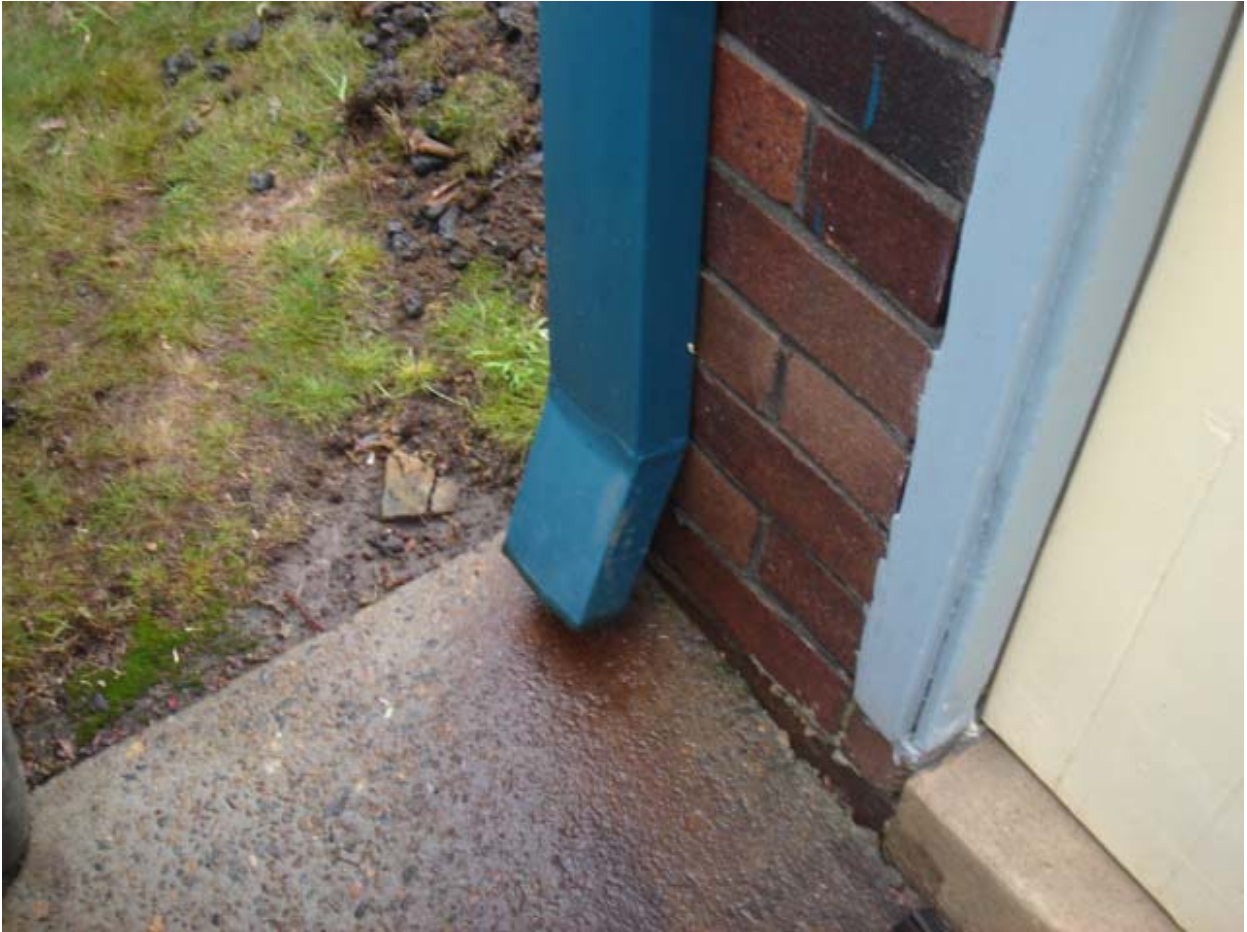
**Photo 1.**

- iv. Metal gutters are full of leaves and dirt and will rust and overflow, possibly allowing rain water entry through the roof if not cleaned out.
  - v. Downpipes collecting rainwater from some gutters are not connected into the stormwater system, discharging their contents on to the surface of the ground contrary to Council and water authority regulations. Rectification of this condition can be enforced by these authorities at the owners expense at some time in the future and costs involved can be in the order of a few thousand dollars depending on the location of the existing stormwater system.

**Downpipes are not connected into the stormwater system, discharging their contents onto the ground contrary to Council and Water Board regulations.**

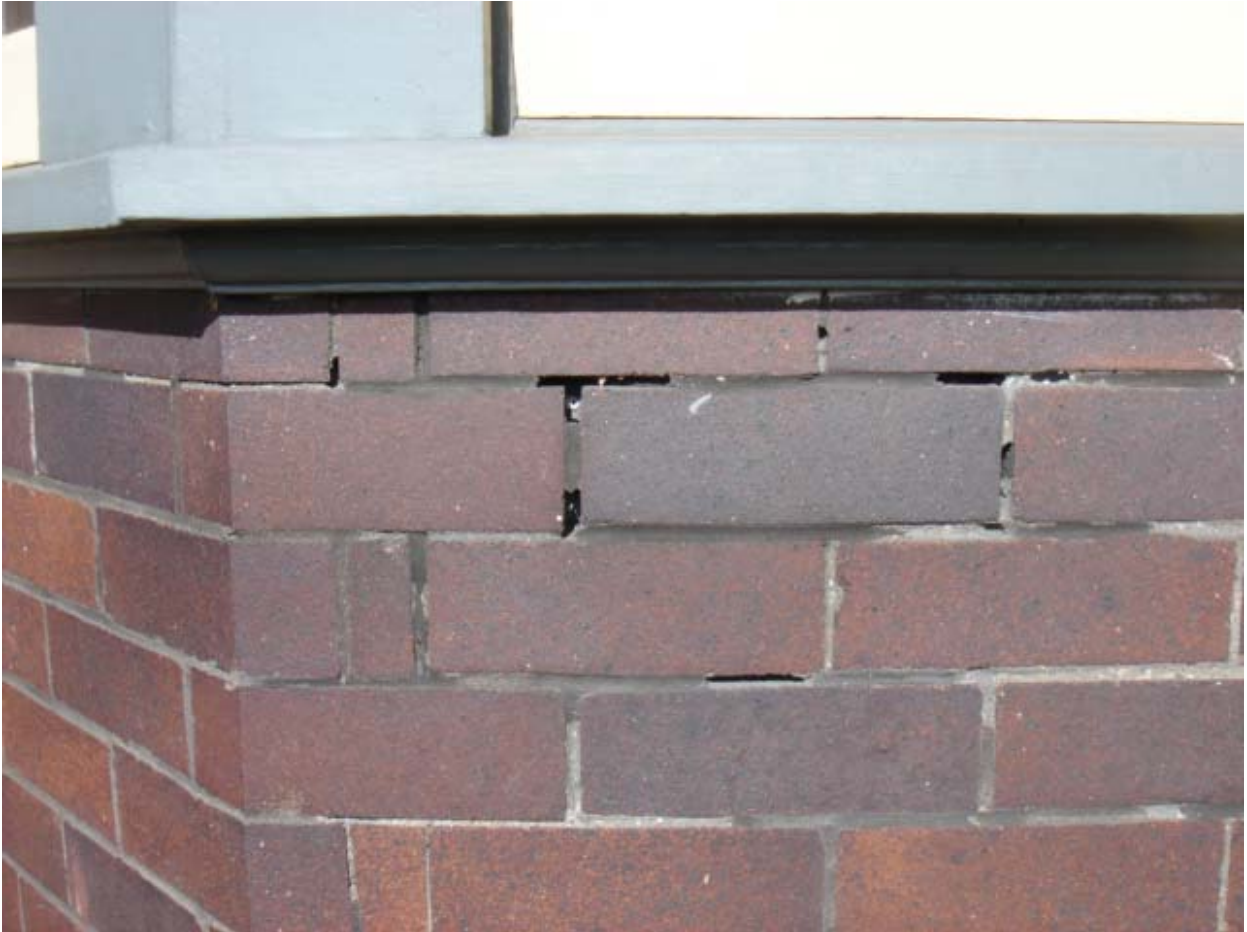
**Photo 2.**

- ii. Mortar joints between the brickwork in the exterior walls are deteriorated in areas and now requires patching, a process known as tuckpointing that can normally be undertaken by a bricklayer with costs involved being in the order of \$500.  
(Photo 2)

**Mortar joints between the brickwork in the exterior walls are deteriorated.**

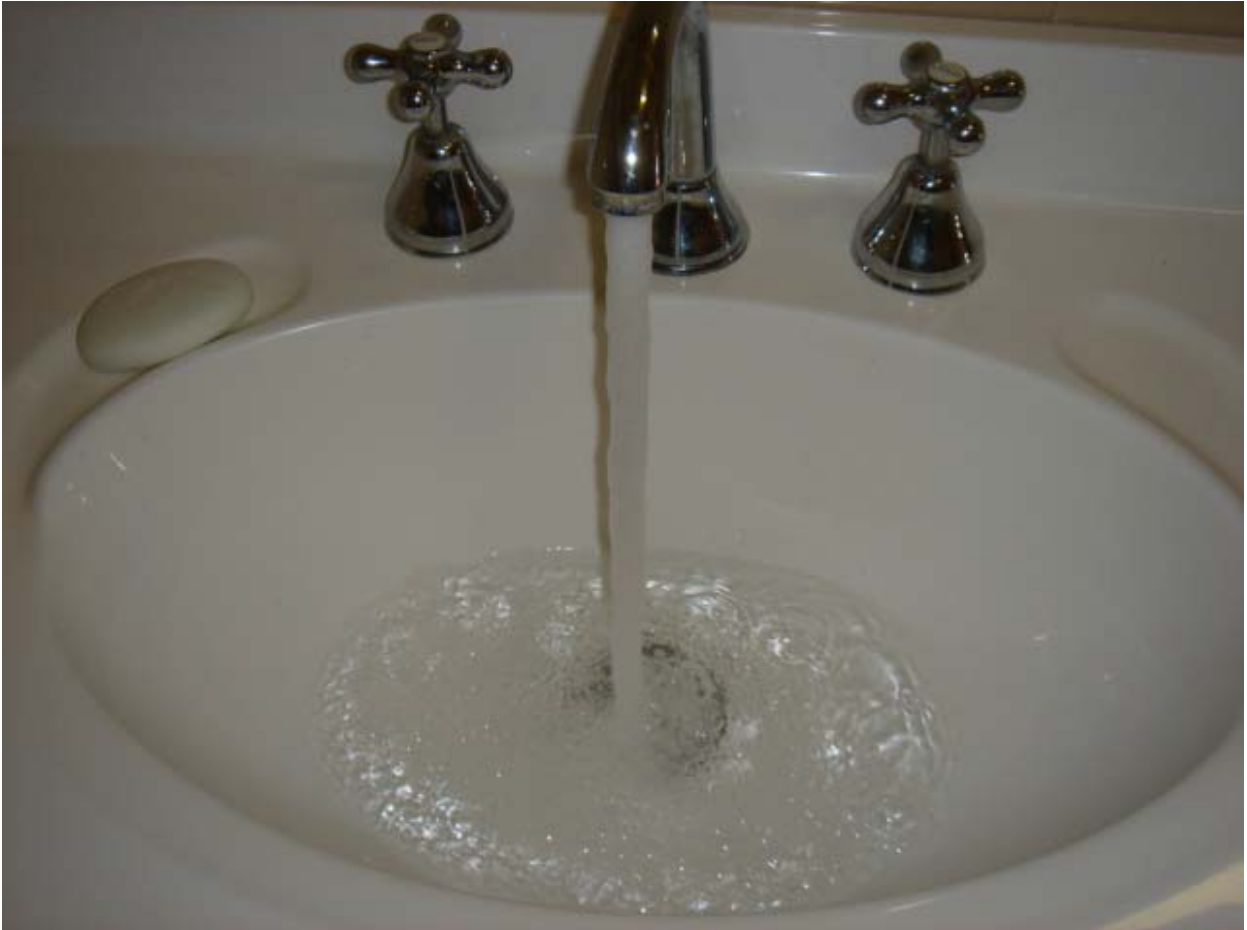
**Photo 3.**

- ii. The handbasin in the bathroom drains slowly, a condition that may be due to a partial blockage in the waste pipe below the handbasin in which case costs involved in rectification will be in the order of \$120, however, should the blockage be in the sewer line, costs involved in repair can be in the order of several thousands of dollars and a plumbing contractor should be engaged to further investigate and rectify this condition. (Photo 4)

**The handbasin in the bathroom drains slowly.**

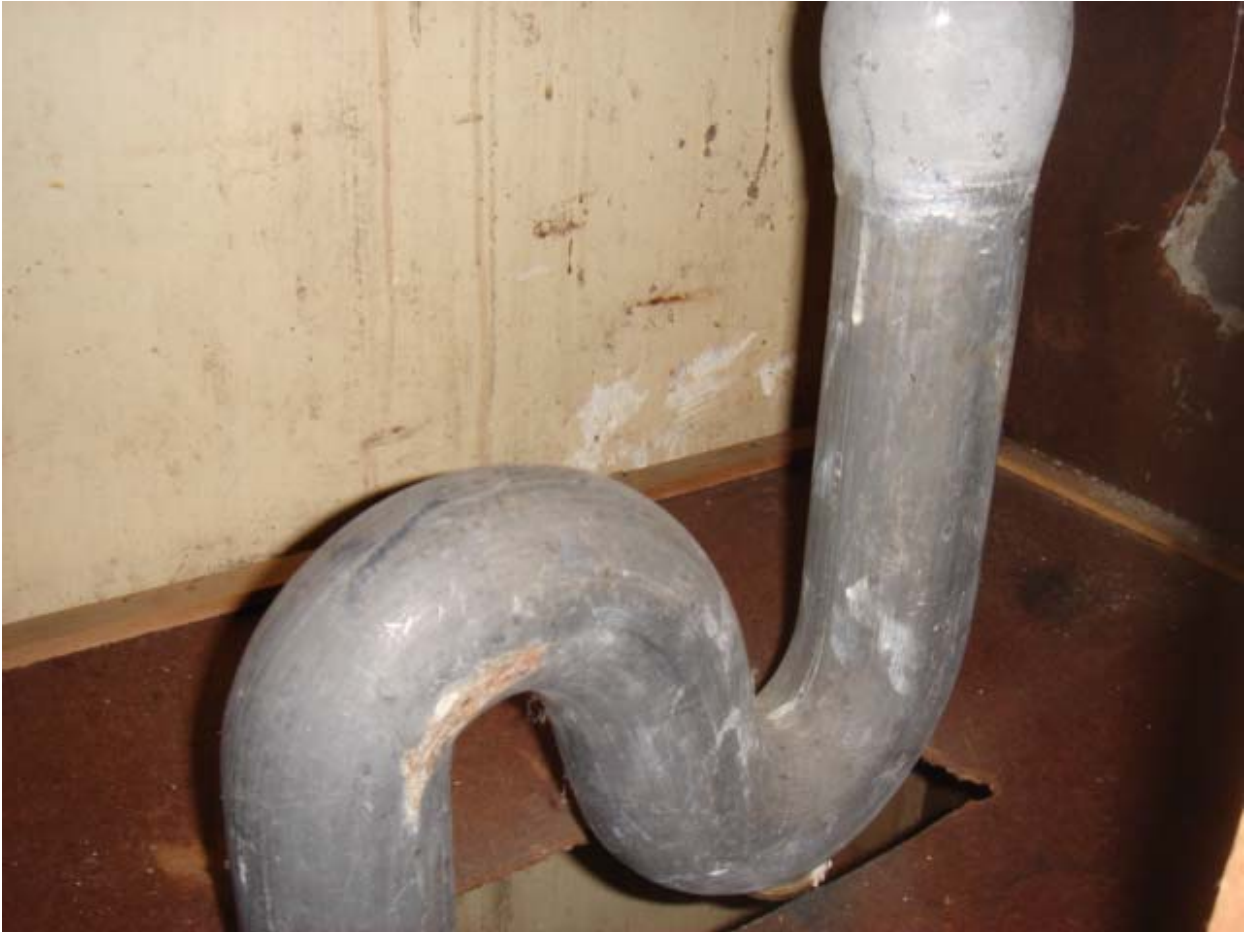
**Photo 4.**

- v. Rubble under the building should be removed.
4. The plumbing installation is in poor condition:
  - i. Iron waste plumbing pipes are corroding. (Photo 5)

**Iron plumbing waste pipes are old and in poor condition.**

A plumbing contractor should now be engaged to rectify the plumbing in this property with costs being in the order of a three thousand dollars, however, should replacement of the sewerage pipes be required, costs involved can be in the order of \$15,000.

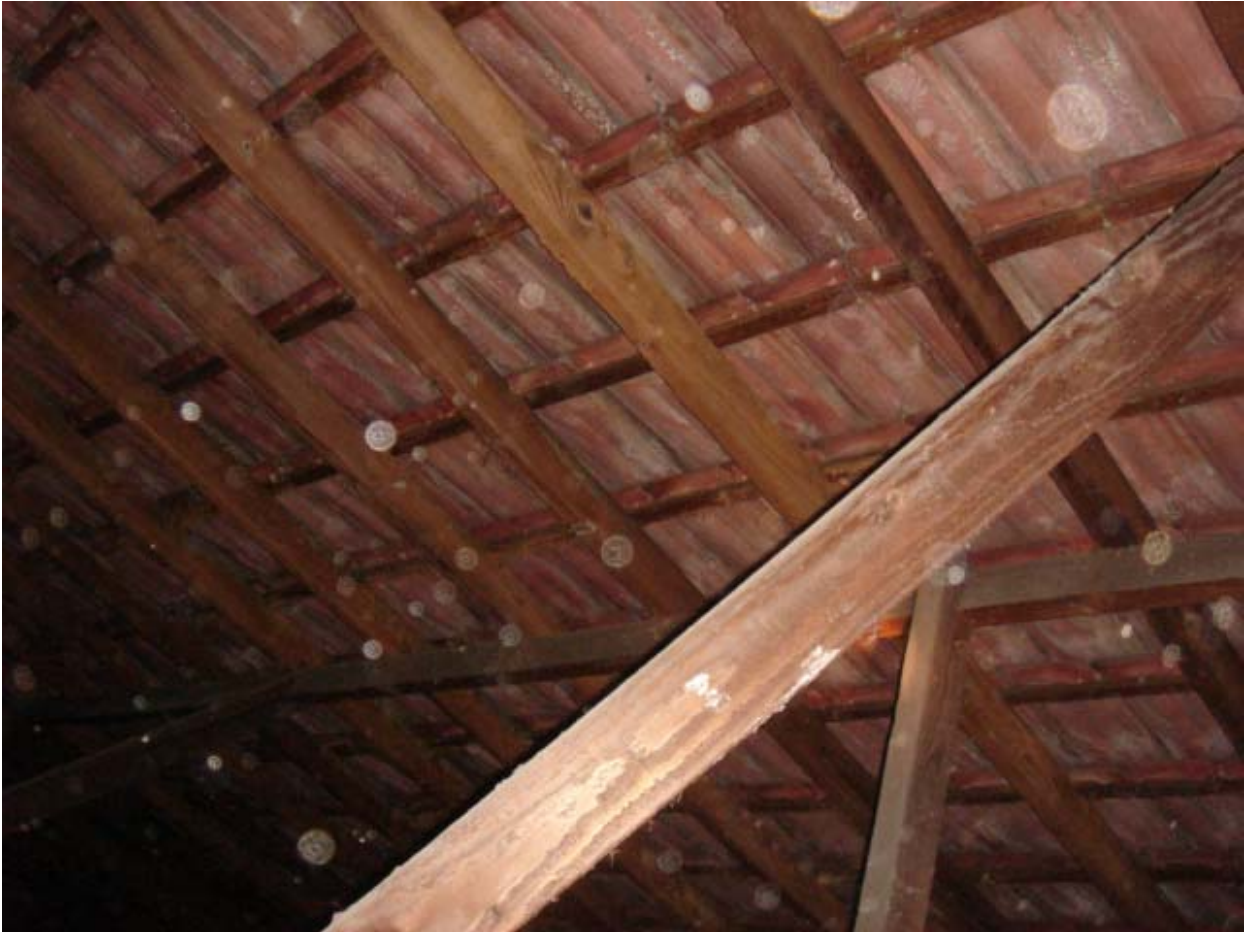
**Photo 5.**

1. Considerable repairs are required to the roof:
  - i. The timber roof framing is sagging below the purlins, being the timber members that support the rafters as visible from within the ceiling cavity and although no immediate instability has resulted, reinforcement of the timberwork should be undertaken by a carpenter with costs involved being in the order of \$1,000.

**View of the timber roof frame.**

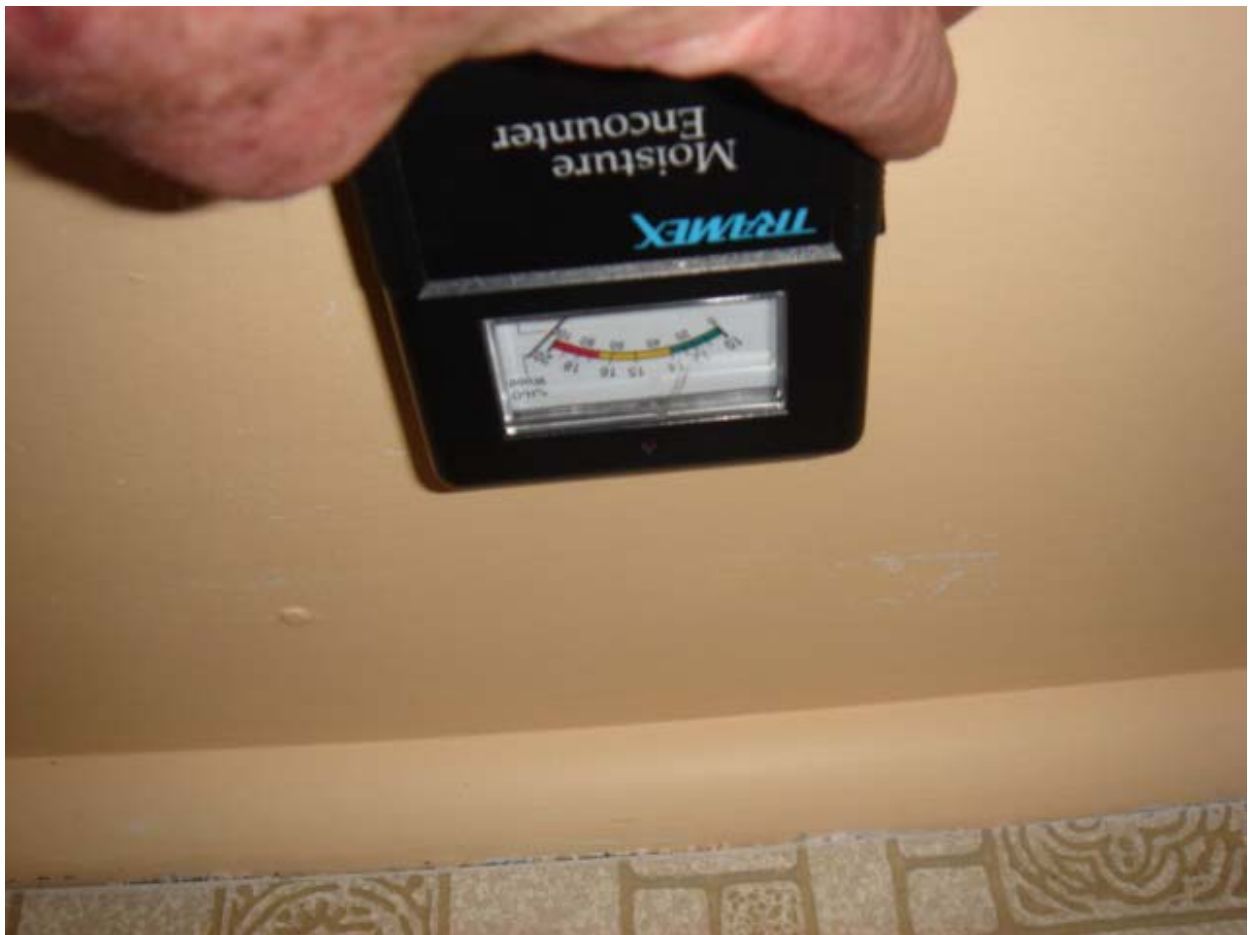
**Photo 6.**

1. Damp meter readings taken about the surfaces of the internal wall linings at the rear of the house revealed a high level of moisture in the walls consistent with the presence of damp, termite infestation and/or termite damage. Further investigation should be undertaken to determine whether termite infestation or damage is present in the concealed timber framework by way of thermal imaging\* or a boroscope test.\*\* (Photo 7)

**Damp meter readings taken along the surfaces of the fibro walls at the rear of the house revealed a high level of moisture in the walls.**
